George Snyder Scout, March 26 & 29, 2020

Observations while walking from the downstream starting point of proposed trail route at Draper Drive and Fairfax Boulevard to upstream end at Chain Bridge Road.

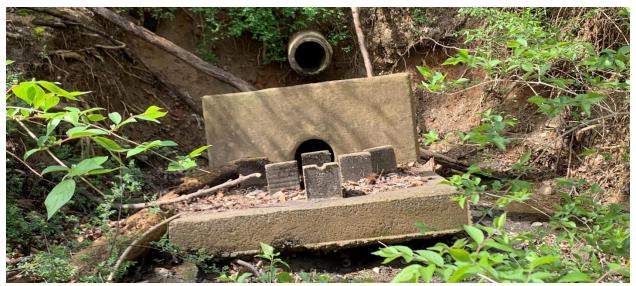
Outfall behind racquet club is collapsed

Collapsed outfall behind racquet club

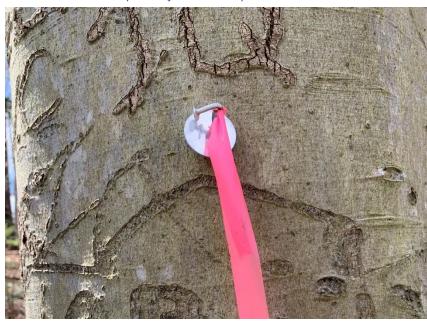
A maintained gravel path from the racquet club to the playground is shown as "existing trail" on plans. Trees marked by silver disks extend all along the proposed route of the trail, indicating they are in the danger zone.

Larger trees are numbered and marked to either remain or be removed

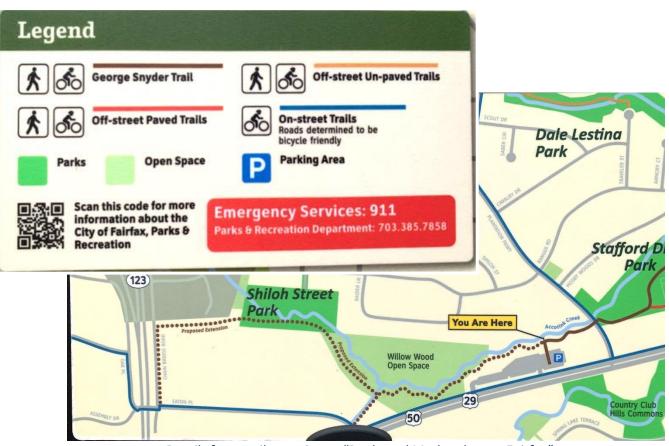
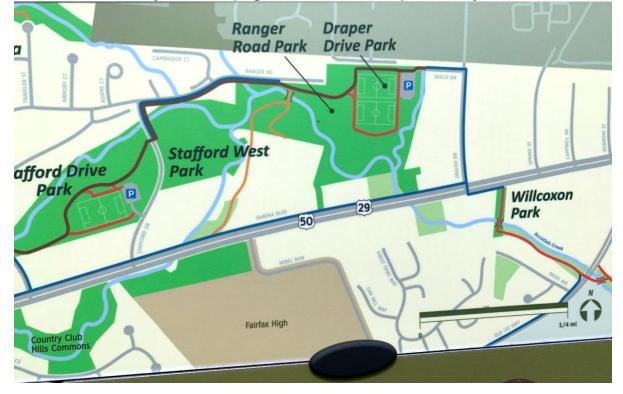
The map sign shows the proposed trail in the woods behind the retail area, but online plans show the trail going along Fairfax Boulevard.

Details from trail map sign at "Boulevard Marketplace at Fairfax"

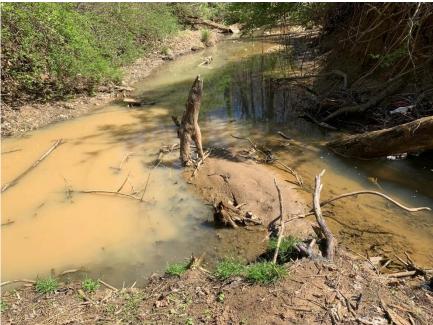
The water of the North Fork is clear, but the Mosby Woods tributary is muddy, attributable to the I-66 construction upstream.

The eastern branch of the Mosby Woods tributary is even more muddy, attributable to the I-66 construction

Muddy water from I-66 construction area meets clearer water from other areas
