George Snyder Scout, March 26 & 29, 2020

Observations while walking from the downstream starting point of proposed trail route at Draper Drive and Fairfax Boulevard to upstream end at Chain Bridge Road.

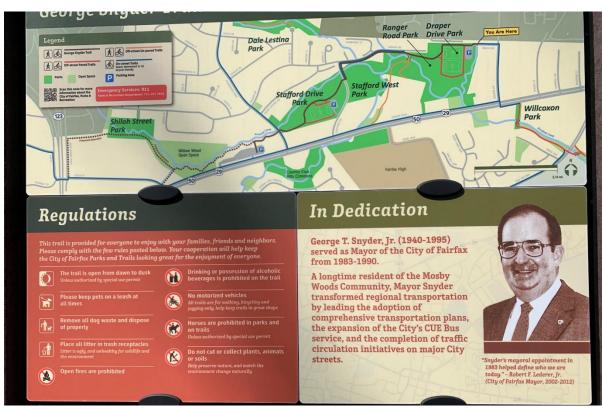
A map sign marks The George Snyder Trail trailhead in Draper Drive Park.

Trail map sign in Draper Drive Park

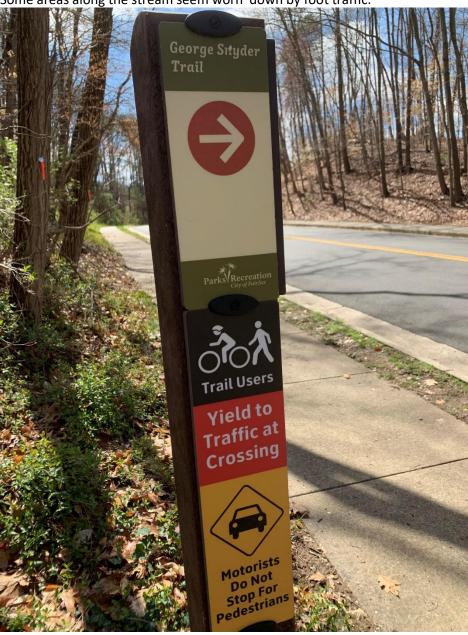
The natural surface path crosses Stafford Drive with no crosswalk, but with signage labeling it part of the George Snyder Trail.

Trail marker at Stafford Drive crossing

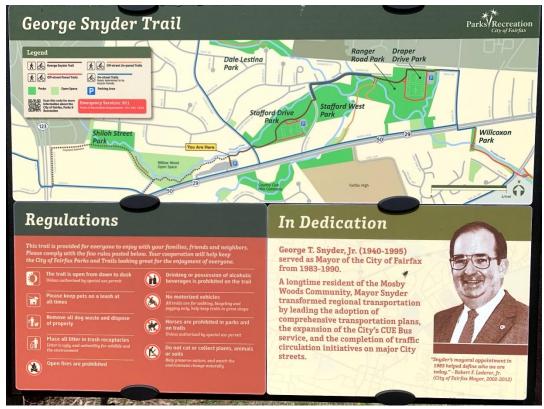
The paved trail terminates in the retail parking area, marked by a George Snyder Trail map sign.

The map sign shows the proposed trail in the woods behind the retail area, but online plans show the trail going along Fairfax Boulevard.

Trail map sign at "Boulevard Marketplace at Fairfax"
