## Long Branch Central Watershed Management Area Implementation Work Plan

### APPROACH TO RESTORING LONG BRANCH

Overall approach to restoring Long Branch consists of four phases. Phase I is nearing completion. Phase IV and public outreach are ongoing.

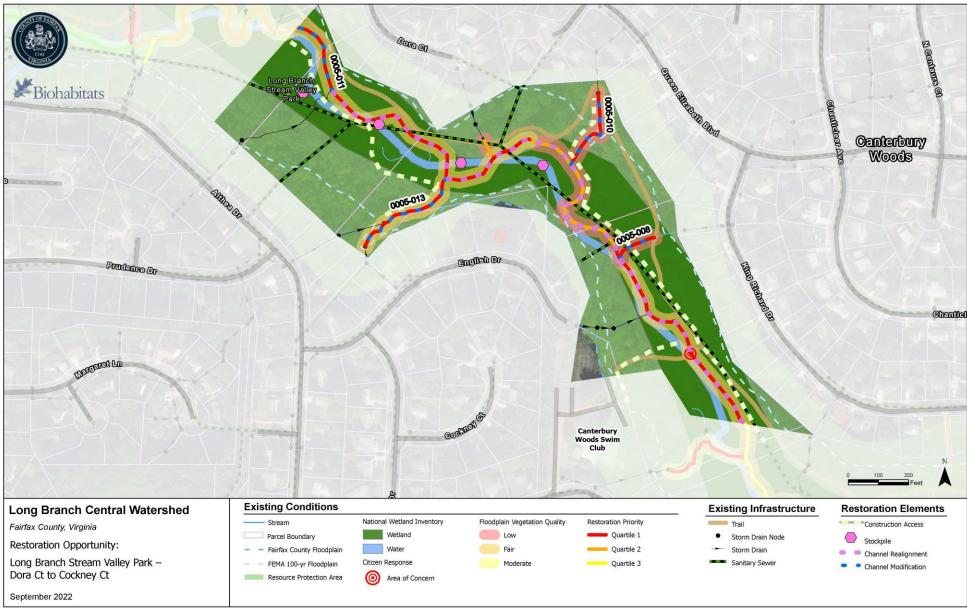
### Long Branch Stream Valley Park – Dora Court to Cockney Court

- Channel restoration of intermittent channels using regenerative stormwater conveyance to capture and infiltrate stormwater, reduce, and prevent channel erosion and elevate and restore ground water elevations which improve channel base flow to better support aquatic organisms.

- Control invasive plant species.
- Conduct restoration planting throughout the floodplain. Note that trees in poor health in the floodplain may be removed to reduce hazard trees, open light gaps to assist in regeneration, and provide large woody debris to improve stream and floodplain stability and habitat and to increase "roughness" to reduce erosion and trap organic debris.

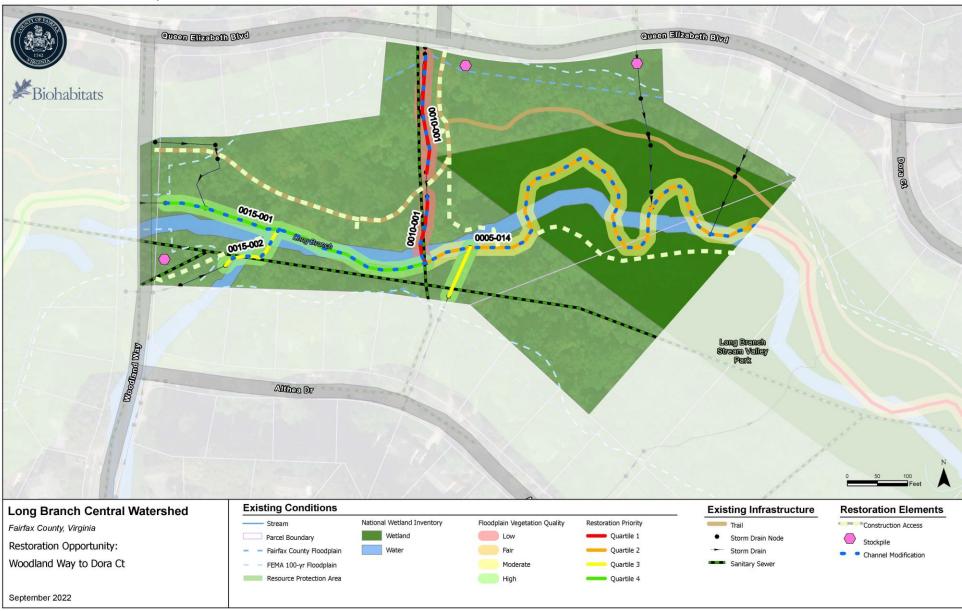
## Woodland Way to Dora Court

This project will focus on protecting existing infrastructure, stabilizing the eroding mainstem and outfall channels to stop current and prevent future channel erosion, and improve floodplain function and aquatic habitat, while protecting the surrounding good quality forest and enhancing areas where the forested stream corridor are degraded.

- Control invasive plant species.
- Conduct restoration planting throughout the floodplain. Note that trees in poor health in the floodplain may be removed to reduce hazard trees, open light gaps to assist in regeneration, and provide large woody debris to improve stream and floodplain stability and habitat and to increase "roughness" to reduce erosion and trap organic debris.

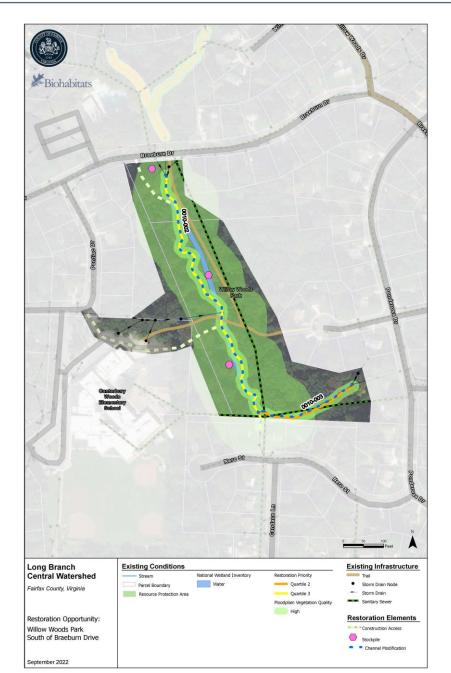
Willow Woods Park South of Braeburn Drive

Three outfalls at upstream end of reach with failing apron structure.

- Restoration planting throughout the floodplain. Trees in poor health may be removed to reduce hazard trees, open light gaps to assist in regeneration, and provide large woody debris.

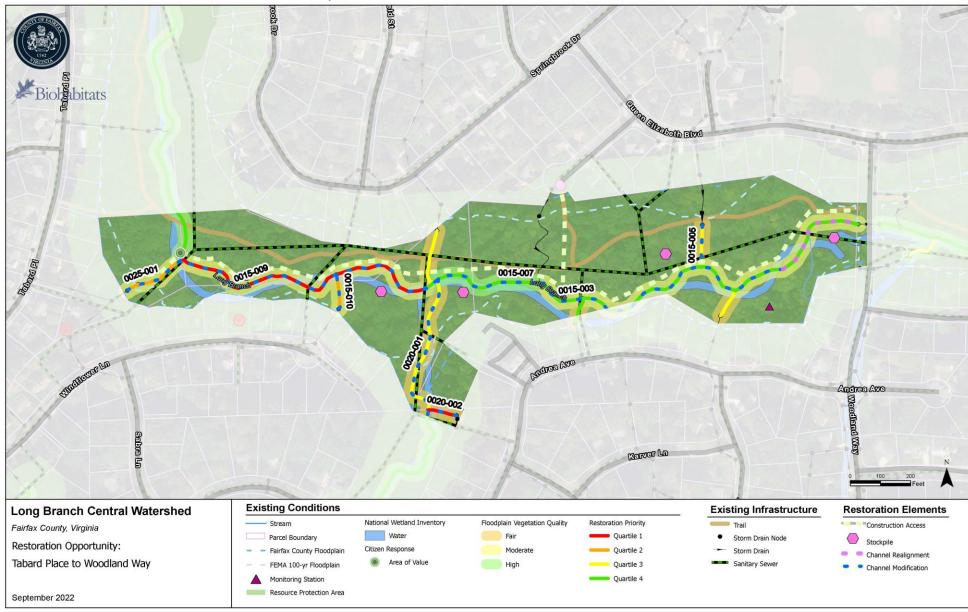
### Tabard Place to Woodland Way

- Placement of wood to increase channel and floodplain "roughness", improve resiliency, and improve both habitat and biodiversity.
- Conduct restoration planting throughout the floodplain. Trees in poor health may be removed to reduce hazard trees, open light gaps to assist in regeneration, and provide large woody debris.

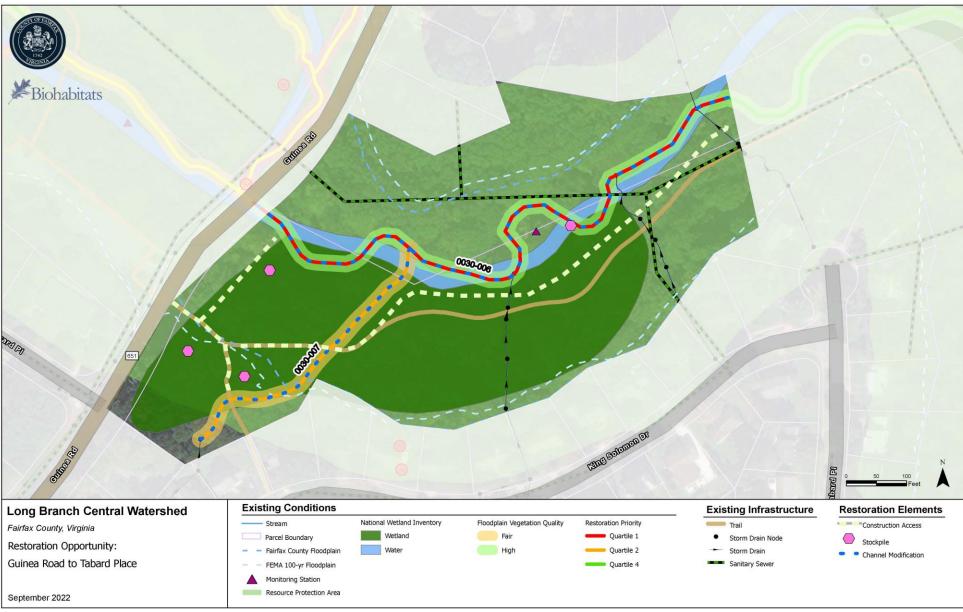
### Guinea Road to Tabard Place

This project will focus on protecting existing infrastructure, stabilizing the eroding mainstem and outfall channels to stop current and prevent future channel erosion, and improve floodplain function and aquatic habitat, while protecting the surrounding sub-optimal quality forest and enhancing areas where the forested stream corridor are degraded.

- Channel restoration of intermittent outfall channel using regenerative stormwater conveyance to capture and infiltrate stormwater, reduce, and prevent channel erosion and elevate and restore ground water elevations which improve channel base flow to better support aquatic organisms.

- Control invasive plant species.
- Conduct restoration planting throughout the floodplain. Note that trees in poor health in the floodplain may be removed to reduce hazard trees, open light gaps to assist in regeneration, and provide large woody debris to improve stream and floodplain stability and habitat and to increase "roughness" to reduce erosion and trap organic debris.

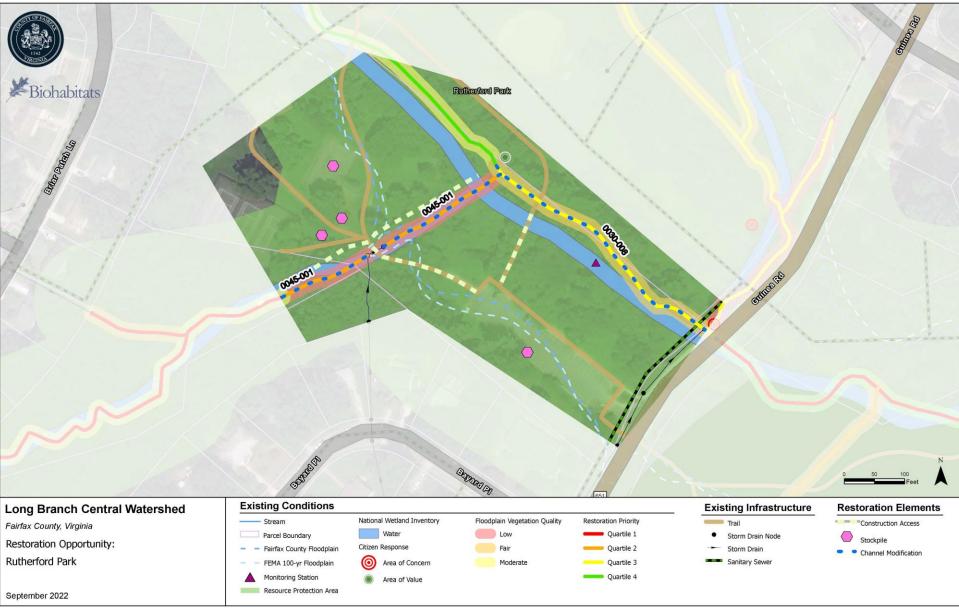
### Rutherford Park

This project will focus on stabilizing the eroding stream channels to stop current and prevent future channel erosion, improving floodplain function and habitat for fish and other aquatic organisms, protecting the previous restoration plantings by Earth Sangha, and enhancing areas where the forested stream corridor is degraded.

- Place rock structures within the stream channels to reduce channel erosion, increase channel "roughness", and improve habitat for fish and other aquatic organisms. Structures will be placed in the current channel extents and some grading will occur.
- Large wood may be placed in the channels on a limited basis to protect banks and improve habitat for fish and other aquatic organisms.
- Control invasive plant species and conduct restoration planting throughout the floodplain. Note that
  trees in poor health in the floodplain may be removed to reduce hazard trees, open light gaps to assist
  in regeneration, and provide large woody debris to improve stream and floodplain stability and habitat
  and to increase "roughness" to reduce erosion and trap organic debris.

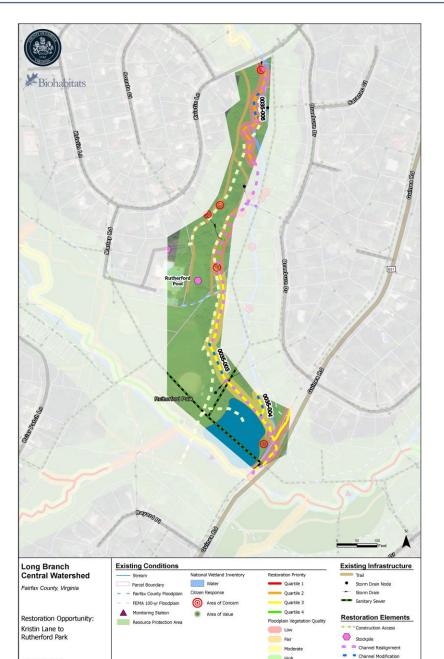
### Kristin Lane to Rutherford Park

- Control invasive plant species.
- Conduct restoration planting throughout the floodplain. Note that trees in poor health in the floodplain may be removed to reduce hazard trees, open light gaps to assist in regeneration, and provide large woody debris to improve stream and floodplain stability and habitat and to increase "roughness" to reduce erosion and trap organic debris.

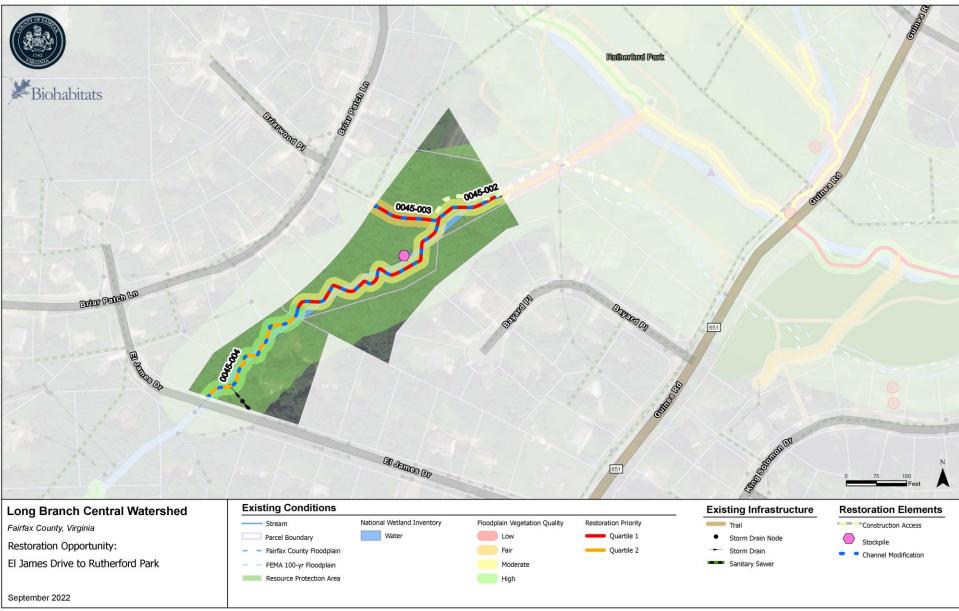
### El James Drive to Rutherford Park

- Channel restoration of outfall channel using regenerative stormwater conveyance to capture and infiltrate stormwater, reduce and prevent channel erosion, while elevating and restoring ground water elevations which improve channel base flow for aquatic organisms.

- Work within the stream and outfall channel where possible to prevent damage to the mature trees, while removing undermined trees on the channel edge to prevent future bank failure.

- Large wood may be placed in the channel on a limited basis to protect banks and improve habitat for fish and other aquatic organisms.
- Conduct restoration planting to enhance the forest condition and improve biodiversity in sub-optimal quality forest and provide young trees and shrubs.

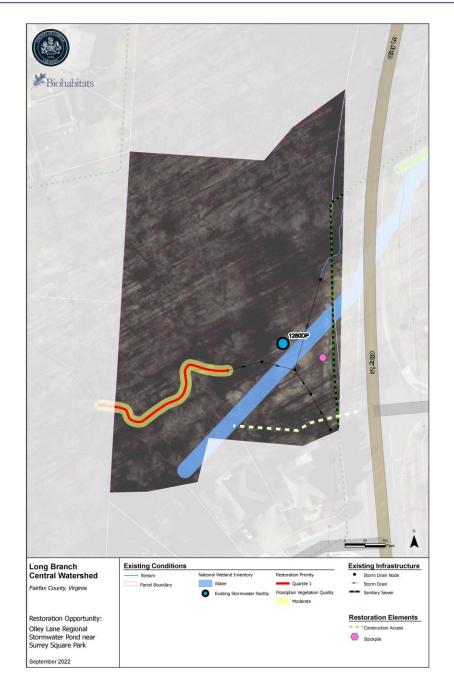
Olley Lane Regional Stormwater Pond near Surrey Square Park

The Olley Lane Regional Stormwater Pond is located just south of Surrey Square Park and was constructed in the late 1990s. A tributary to Long Branch flows from the northwest through a partially eroded channel into the pond, and then continues downstream of Olley Lane on landed owned by Fairfax County. The restoration project area includes the pond and eroded portion of the stream channel to the north. To the east and west, the pond is surrounded by private property. The existing pond bottom is wet and invasive species including phragmites dominate the groundcover. Some repairs are needed in stream channel, within the pond itself, and at the outfall structure.

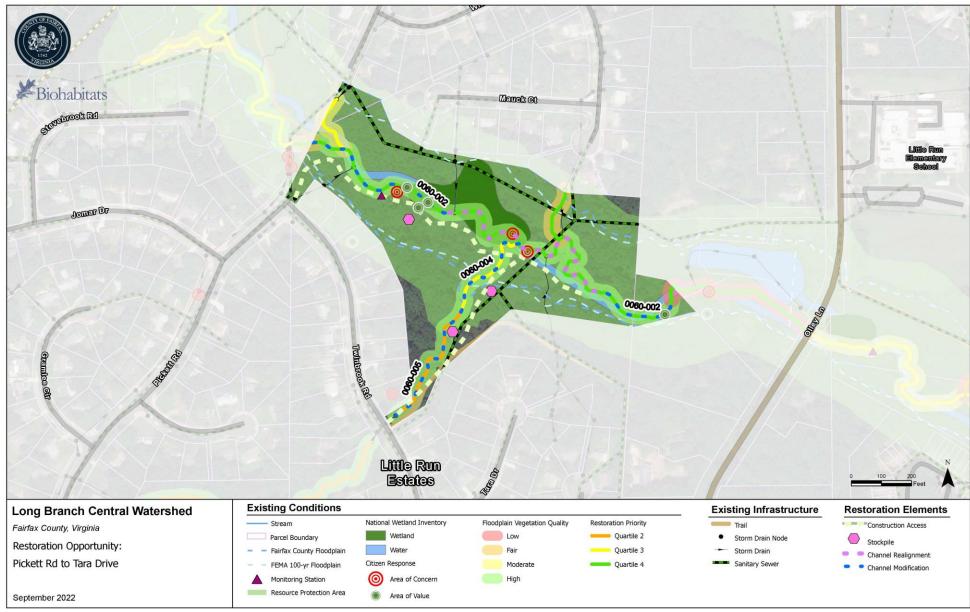
### Pickett Road to Tara Drive

The Pickett Road to Tara Drive project is located on Fairfax County Park Authority with a potential to extend the project onto private property. The project area is bound by private properties to the northwest and southeast and includes 2,560 linear feet of stream, regulated floodplains and wetlands, and a forested stream corridor dominated by mature mesic floodplain tree species. The existing understory vegetation is of optimal quality upstream of the confluence with the stream flowing from Olde Forge Park under Twinbrook Road with few invasive plant species present. The forest condition is more degraded along this stream and along the mainstem downstream of the confluence although there are many mature trees. A high traffic asphalt and natural surface trail along with an existing playground and basketball court is located within the project area.

This project will focus on stabilizing the eroding mainstem and outfall channels to stop current and prevent future channel erosion, improving floodplain function and habitat for fish and other aquatic organisms, while protecting the high quality forest along the mainstem upstream of the confluence with the tributary from Twinbrook Road as well as mature trees throughout the project area to the greatest extent possible and enhancing areas where the forested stream corridor is degraded.

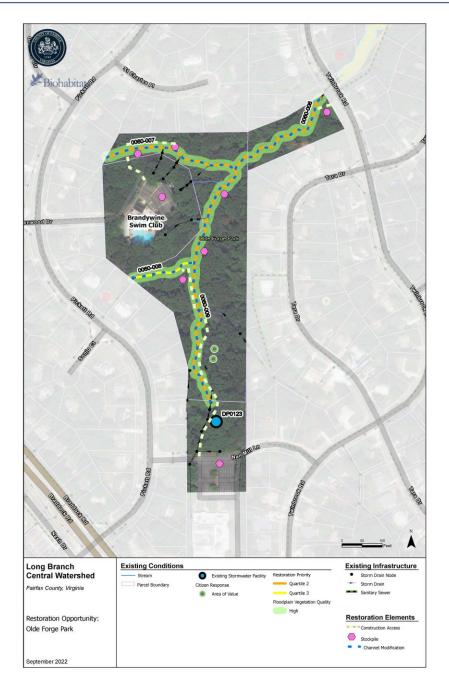
# Olde Forge Park

The Olde Forge Park project is located on Fairfax County Park Authority property east of Pickett Road between Nan Mill Lane and Twinbrook Road, and potentially includes land owned by the Korean Presbyterian Church of Washington and the Brandywine Swim Club. The restoration project area includes an existing stormwater pond, several degraded outfalls and 2,180 linear feet of stream channel located within a forested stream corridor dominated by mature mixed hardwood tree species. The existing understory vegetation is of optimal quality with a few invasive plant species present, although the presence of wavy-leaf basket grass was noted. Private properties surround the forested corridor in all directions.

This project could include improvements to the stormwater pond and concrete channel outfalls on private property to increase stormwater detention and reduce erosive outfall flows. The project will include restoration of the channels on parkland to capture stormwater flows, stop current and prevent future channel erosion, protection of the surrounding, good quality upland forest, and restoration plantings to enhance areas where the forested riparian corridor are degraded near the church stormwater pond and the swim club outfalls.

- Potential outfall improvements from Brandywine Swim Club to reduce channel erosion.
- Channel restoration of intermittent channels in Olde Forge Park using regenerative stormwater conveyance to capture and infiltrate stormwater, reduce and prevent channel erosion, while elevating and restoring ground water elevations which improve channel base flow for aquatic organisms.

- Restoration of perennial portions of the stream to reduce erosion and protect surrounding forests from continued tree loss.
- Work within the stream channels to prevent damage to surrounding good quality upland forest, while removing undermined trees on the channel edge to prevent future bank failure.

- Control invasive plant species.
- Conduct restoration planting to supplement good quality forest and provide young trees and shrubs to replace those lost due to excessive deer browse.

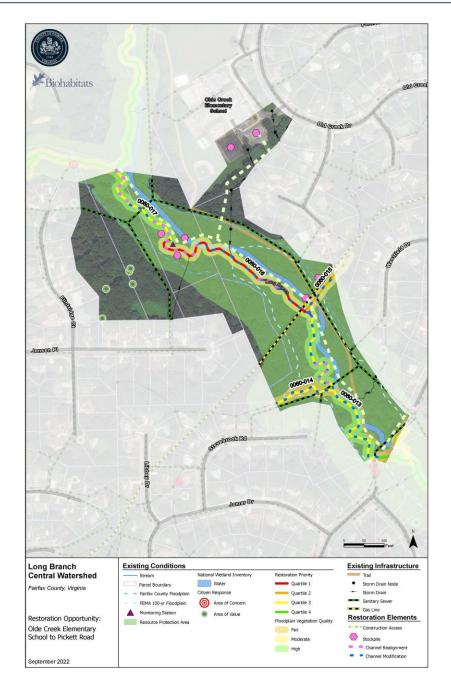
Olde Creek Elementary School to Pickett Road

- Channel restoration of the ephemeral channel using regenerative stormwater conveyance to capture and infiltrate stormwater, reduce and prevent channel erosion, while elevating and restoring ground water elevations which improve channel base flow to better support aquatic organisms.

- Placement of wood to increase floodplain "roughness", improve resiliency, and improve both habitat and biodiversity throughout the floodplain.
- Control invasive plant species and conduct restoration planting throughout the floodplain. Trees in poor health may be removed to reduce hazard trees, open light gaps to assist in regeneration, and provide large woody debris.

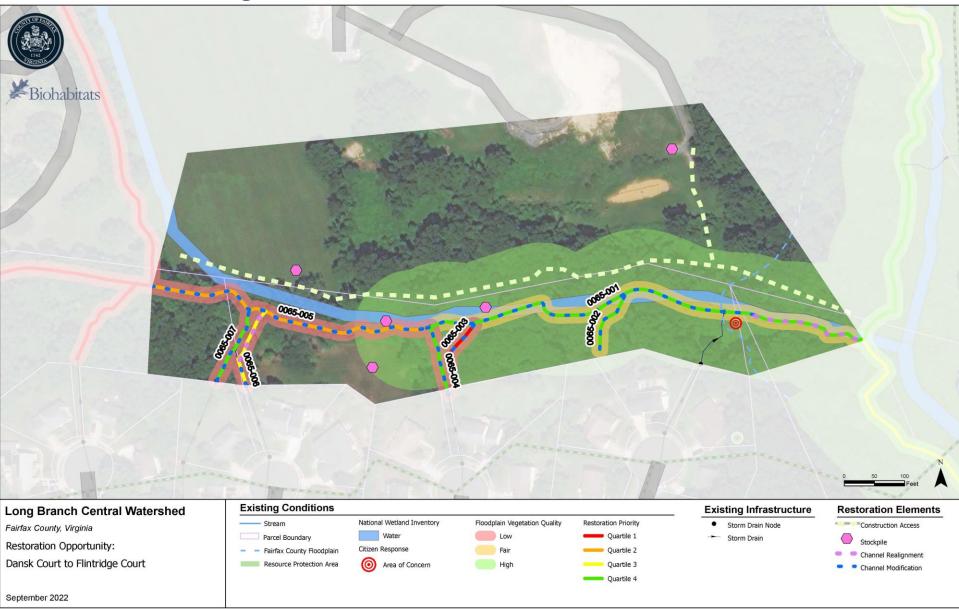
## Dansk Court to Flintridge Court

- Conduct restoration planting throughout the floodplain. Trees in poor health may be removed to reduce hazard trees, open light gaps to assist in regeneration, and provide large woody debris.

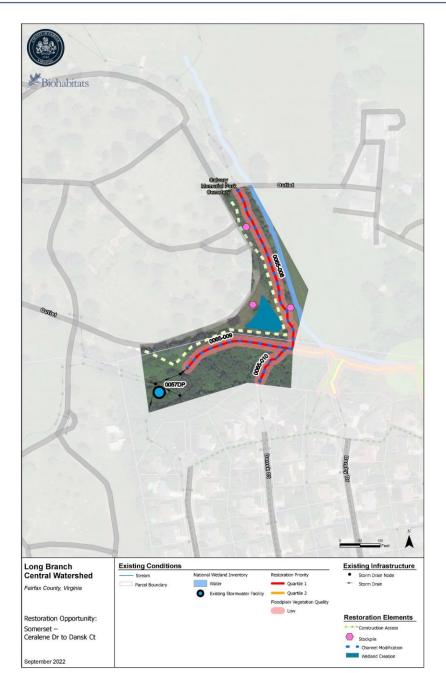
The Somerset – Ceralene Drive to Dansk Court project is located north of Ceralene Drive, and potentially includes land owned by Somerset South Homeowner Association and Fairfax Memorial Park. The restoration project area includes an existing stormwater pond, a degraded outfall channel and 1,230 linear feet of stream channel located within a forested stream corridor with some mature trees. The existing understory vegetation is of poor quality and is dominated by invasive plant species. Private properties surround the forested stream corridor in all directions. There is a natural surface trail through this restoration project area.

This project could include improvements to the county-maintained stormwater pond on Somerset South Homeowner Association property to increase stormwater detention and reduce erosive outfall flows. The project could also include the restoration of the perennial stream and outfall channels located on private property to capture stormwater flows, stop current and prevent future channel erosion, and conduct restoration plantings to enhance the degraded forested stream corridor.

- Potential stormwater pond retrofit on the Somerset South Homeowner Association property to maximize storage, provide water quality using a wetland bottom within the pond, and reduce intensity of water leaving the pond to reduce channel erosion.
- Place woody structures within the perennial stream to reduce channel erosion and protect surrounding forests from continued tree loss.
- Control invasive plant species.
- Conduct restoration planting throughout the floodplain. Trees in poor health may be removed to reduce hazard trees, open light gaps to assist in regeneration, and provide large woody debris.

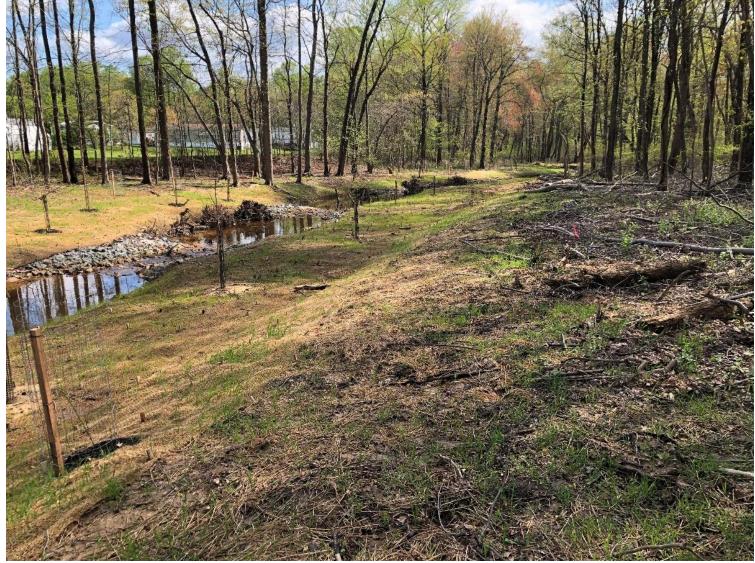
#### **Bank Protection**

Bank protection is one method to reduce erosive impacts on a stream bank. Boulders and/or tree rootwads can be positioned along the toe of an eroded bank and back filled with soil to create a new stable bank. Boulders provide a higher degree of stability for higher flows whereas rootwads provide increased habitat in addition to protection for moderate to low flows.

River Valley Ranch Baltimore County, MD

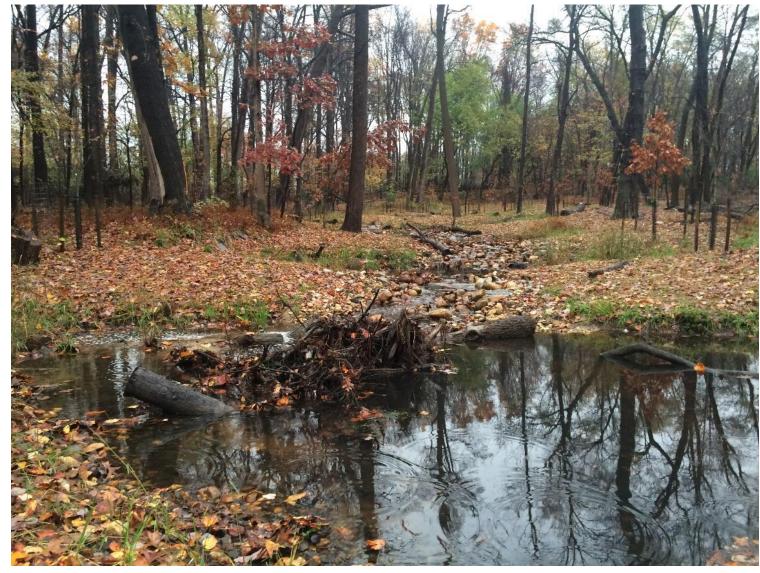
#### Floodplain Bench

Floodplain benches are implemented on either side of a pilot channel with natural geometry that handles typical baseflows. The bench provides a larger cross section with handles flows above baseflow, reducing flow velocity through surface roughness and protecting the stream bank. Floodplain benches can be used within over widened channels or areas in which the stream invert cannot be raised.

Brentwood Manor Howard County, MD

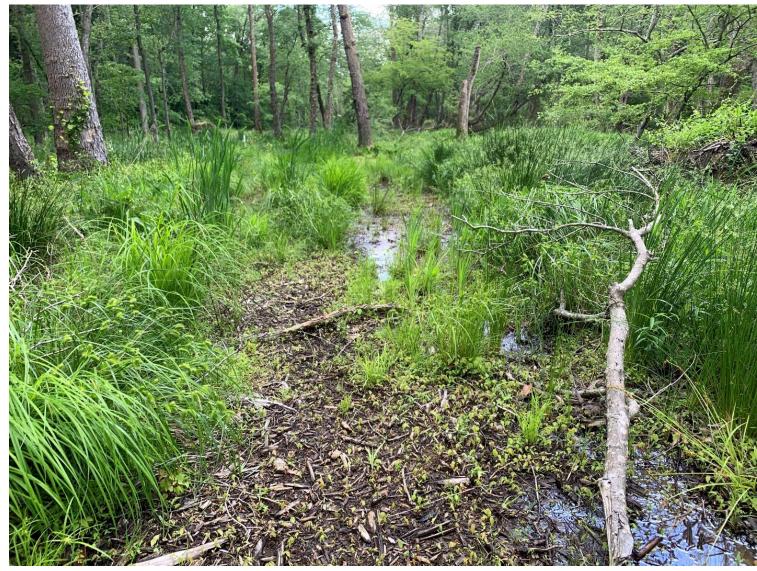
#### Large Woody Debris

Large woody debris are added to provide increase roughness, promote flow diversity, bank protection, and add habitat complexity to stream systems, most typically in constructed pools. Large woody debris can be added along a bank for bank protection or in the center of a pool for added roughness and habitat.

Breewood Montgomery County, MD
